# Surface Contaminants of Niobium

by Dan Kapner

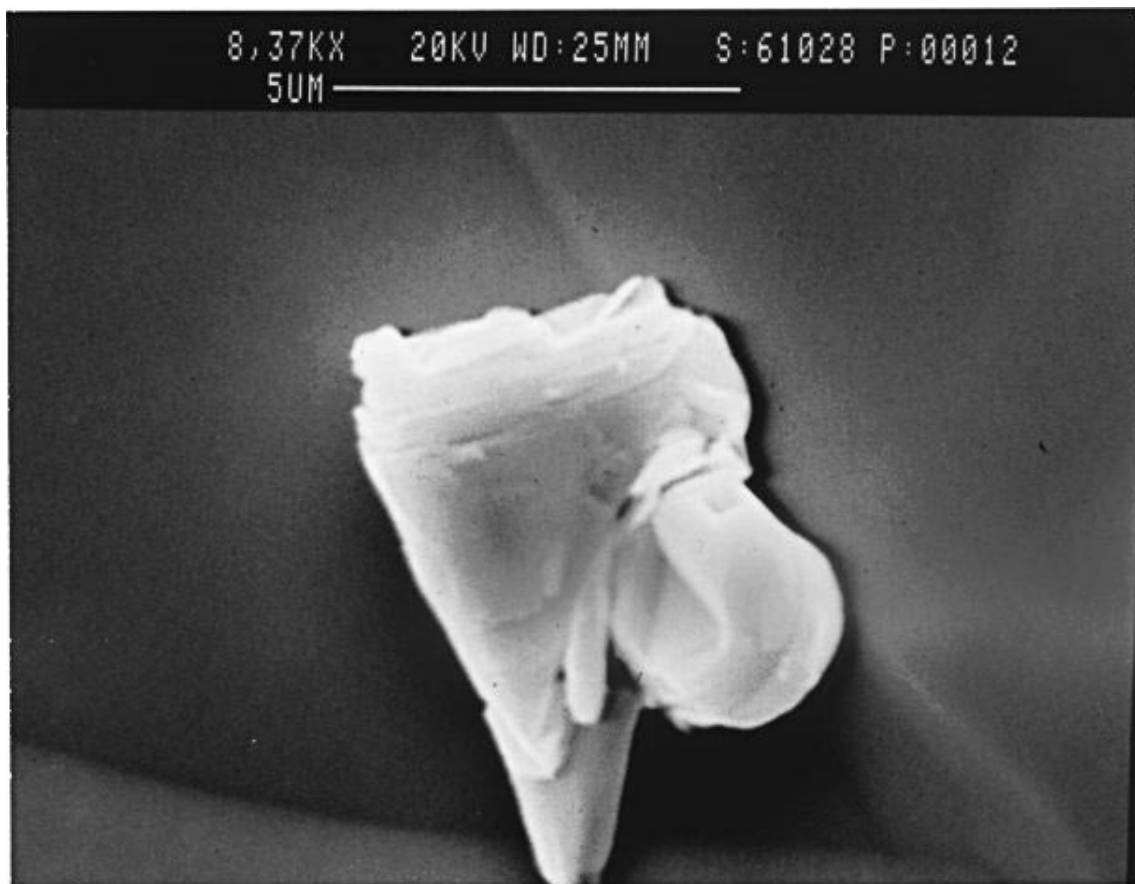
Figure 1 : A particle made of Tellurium and Copper found on coupon B2-68, probably collected during extended drying.

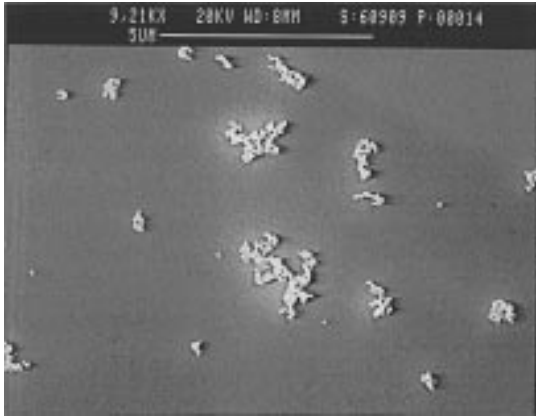
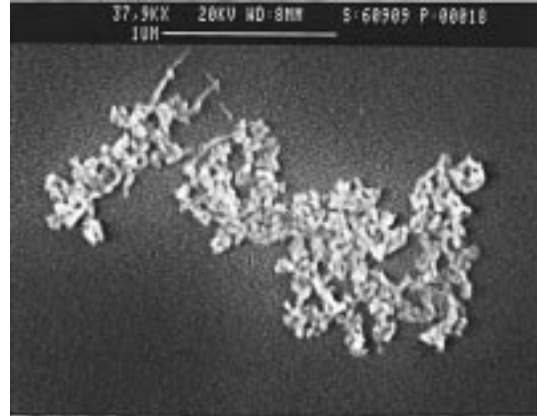
Figure 2 : Hafnium contaminants found on coupon A1-39. Hafnium contaminants were found after short and long etchings of the Teledyne niobium.

The Russian niobium is remarkably cleaner than the Teledyne. Most remarkable is the complete absence of hafnium. It turns out that in the same plant that processes the Teledyne niobium, hafnium is also processed. This seems a likely source of the hafnium contamination on the Teledyne samples.

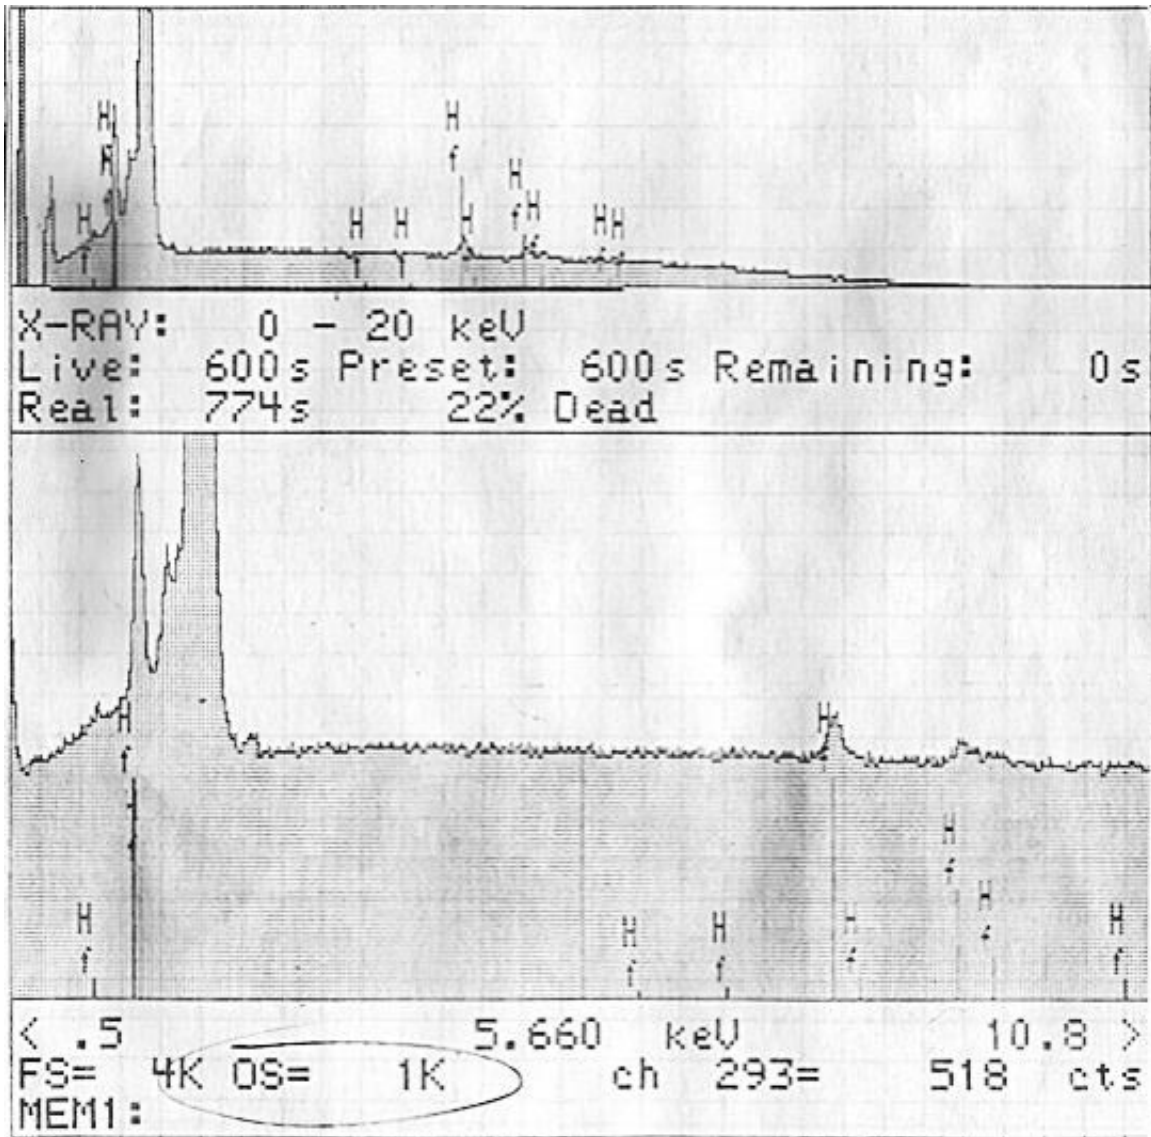
Figure 3 : An EDX spectrum of a particle containing Hf.

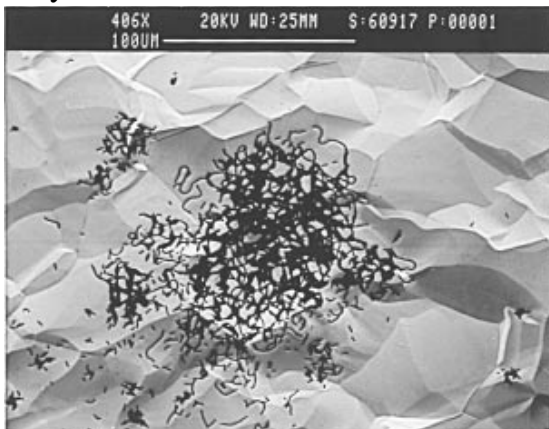
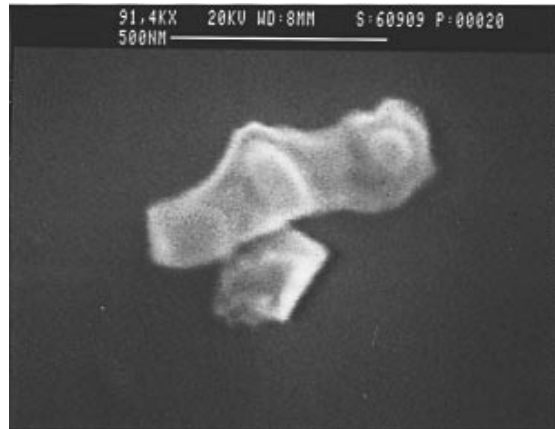
Later, a coupon C1, etched in sulfuric acid overnight and then etched in BCP for four minutes, provided similar results. By this point, a niobium sample holder had been substituted for the aluminum one, suspecting that this holder was a source of aluminum particles like the one shown in figure 4.

Figure 4 : Residue after a twelve day submersion in de-ionized water on A2-39 (left) and an Aluminum contaminant found on A1-39.

Meanwhile, coupon A2-39 had been sitting in de ionized water for twelve days and the surface was now contaminated with dark masses of curved lines (figure 4). Unfortunately, these lines provided no spectrum. We soon realized that the x-ray spectrometer's computer was set so that any peak that had the energy equal to or less than the carbon K line would not be shown. It is possible that these contaminants were carbon, possibly some bacteria that grew on the surface during its twelve day submersion. The coupon was then re-etched for four minutes, rinsed and dried: At this point the niobium sample holder replaced the aluminum sample holder. The sample holder was made, cleaned, and etched in sulfuric acid and water overnight, and then etched for about an hour in BCP.

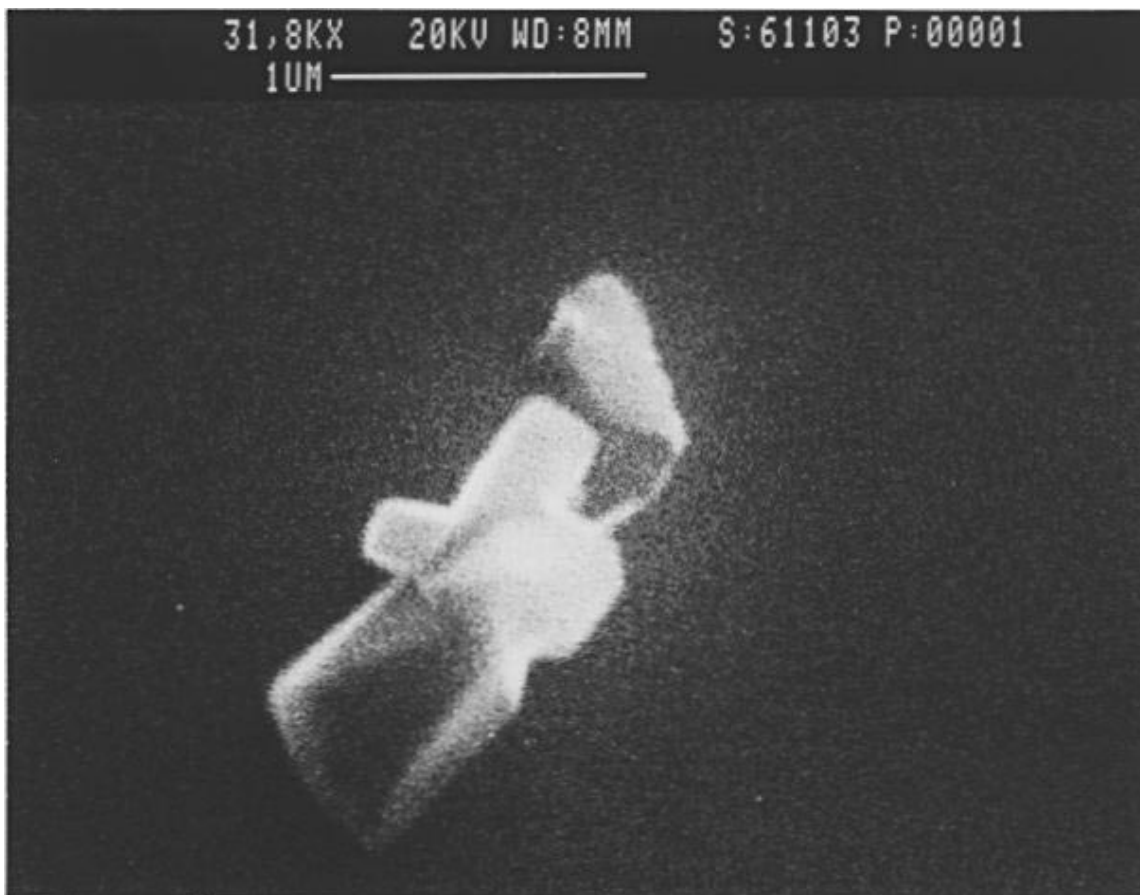
Figure 5 : A carbon contaminant found on B2-68.

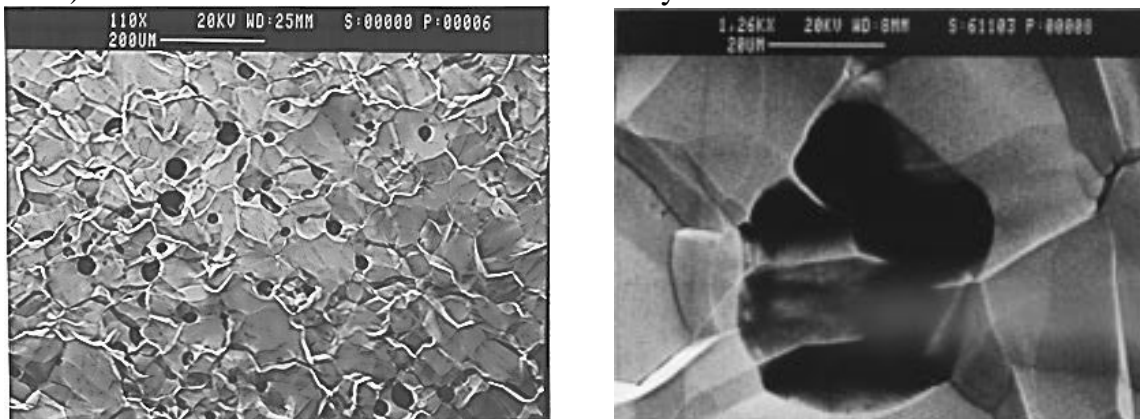
Figure 6 : Carbon splotches found on B2-68, probably a result of water running off the Teflon cover.

Inside the depression there was a high concentration of carbon splotches (figures 6, 7, 8, 9) (by this point the spectrometer's computer had been readjusted to show all peaks). Outside the depression there were some similar splotches, but fewer in density than inside. It is likely that the source of these carbon splotches was the Teflon cover, as no splotches were seen when water was dripped off niobium. There were also some carbon particles found on these coupons (figure 5).

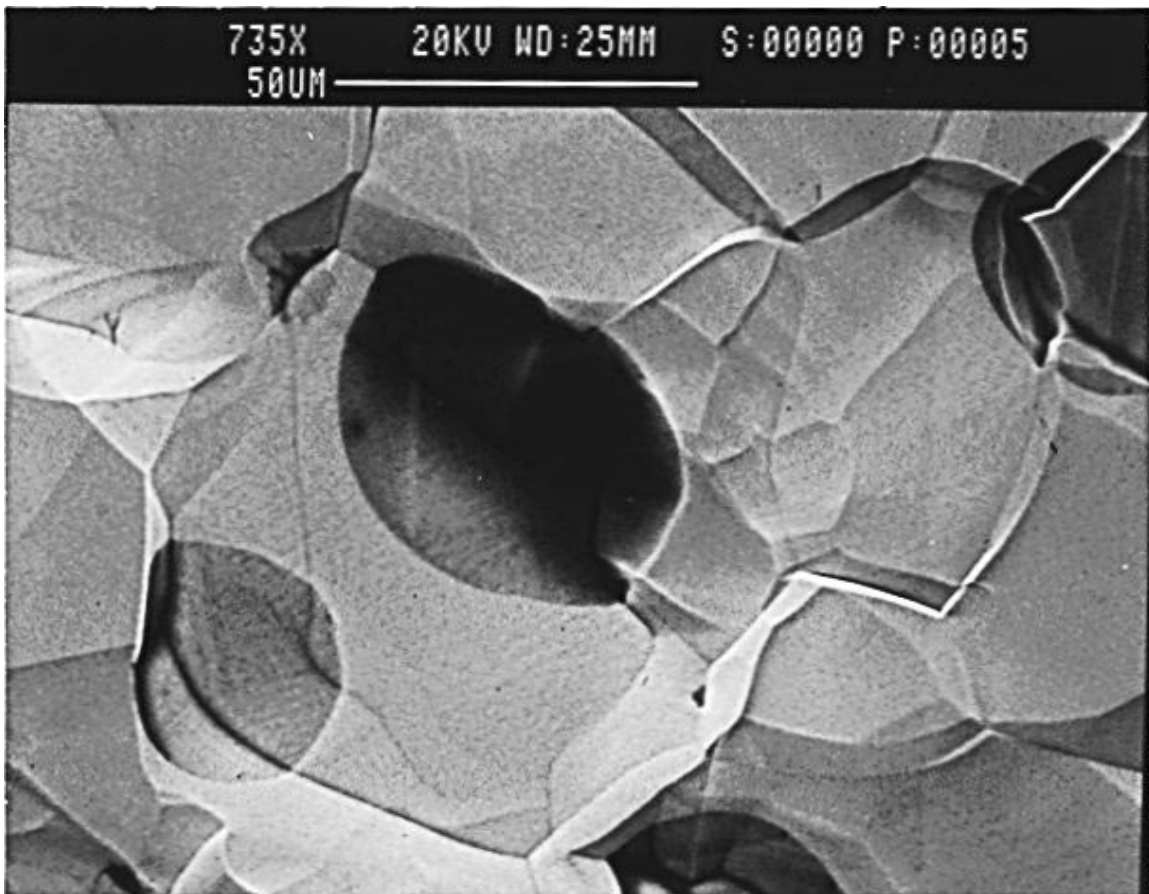
Figure 7 : A carbon splotch on Coupon B2

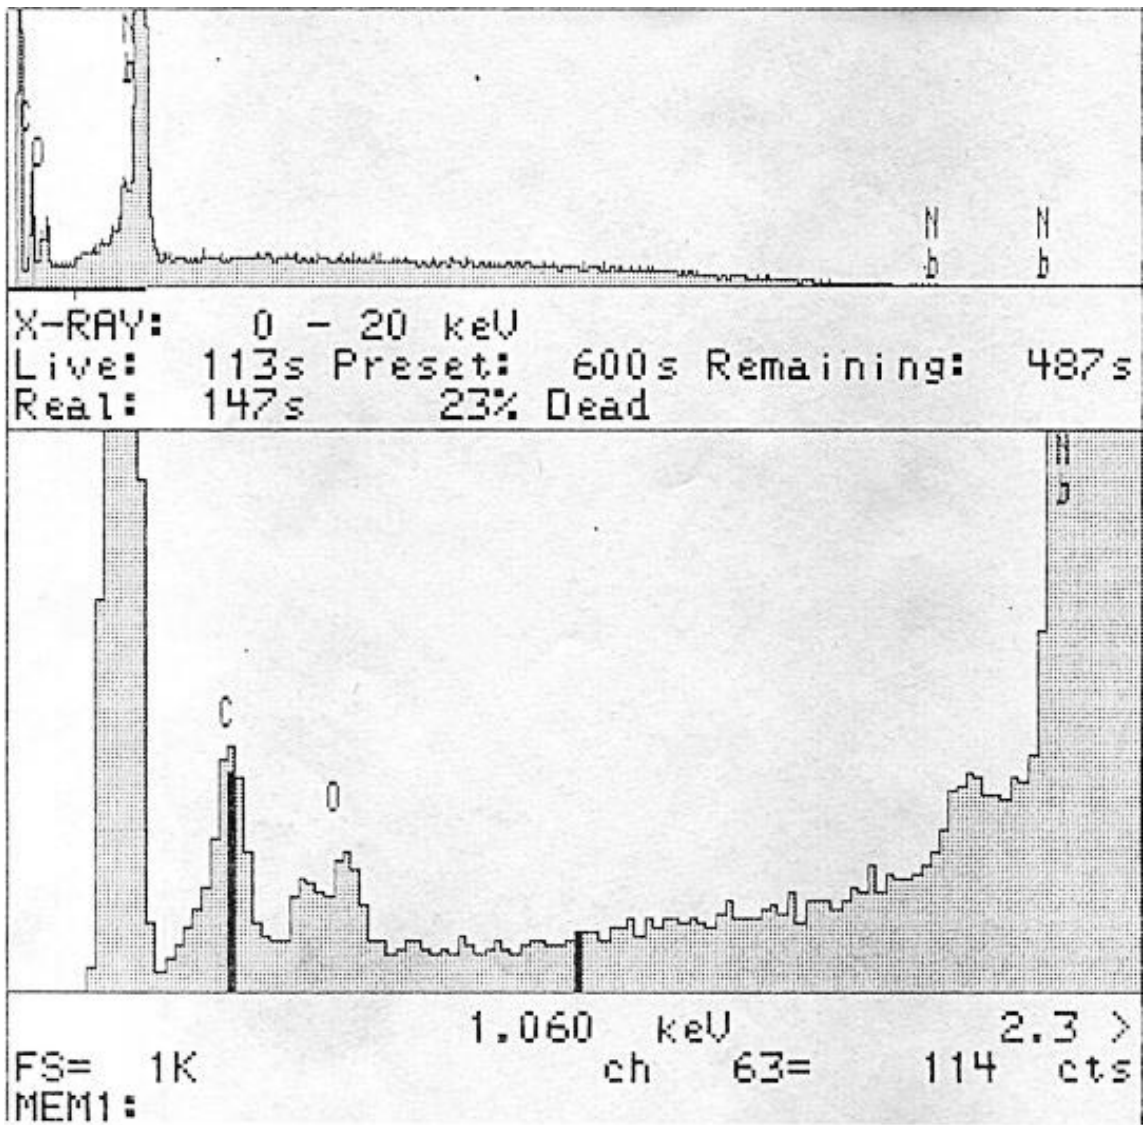
Figure 9 : An EDX spectrum of a particle containing carbon.

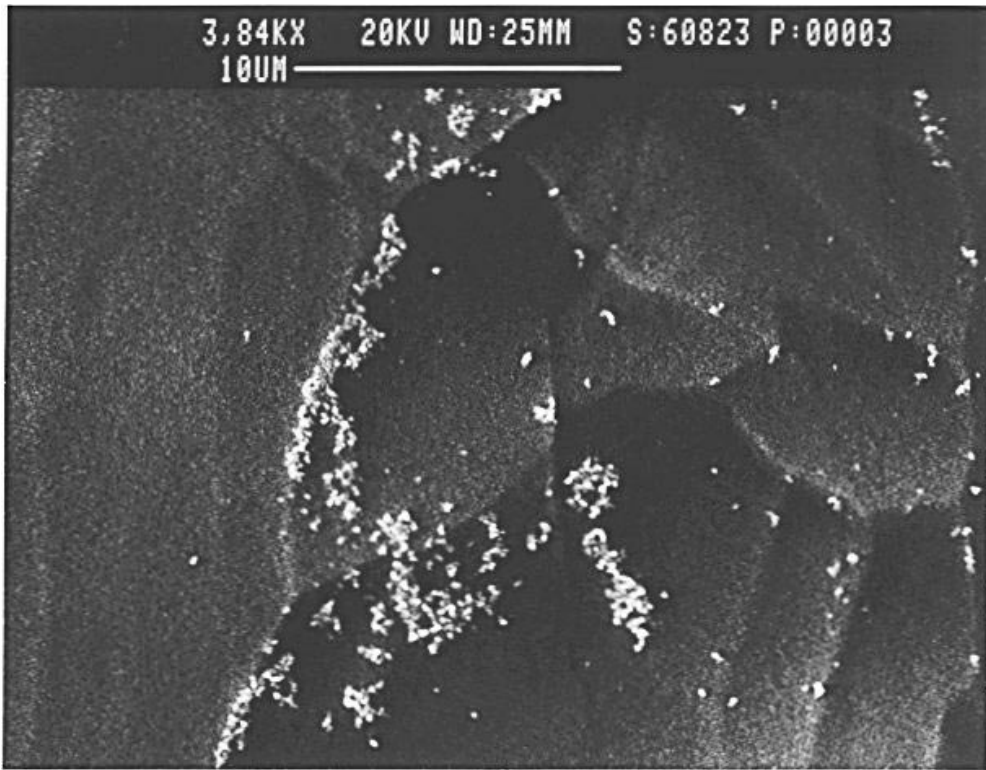
Silicon particles on coupon A1

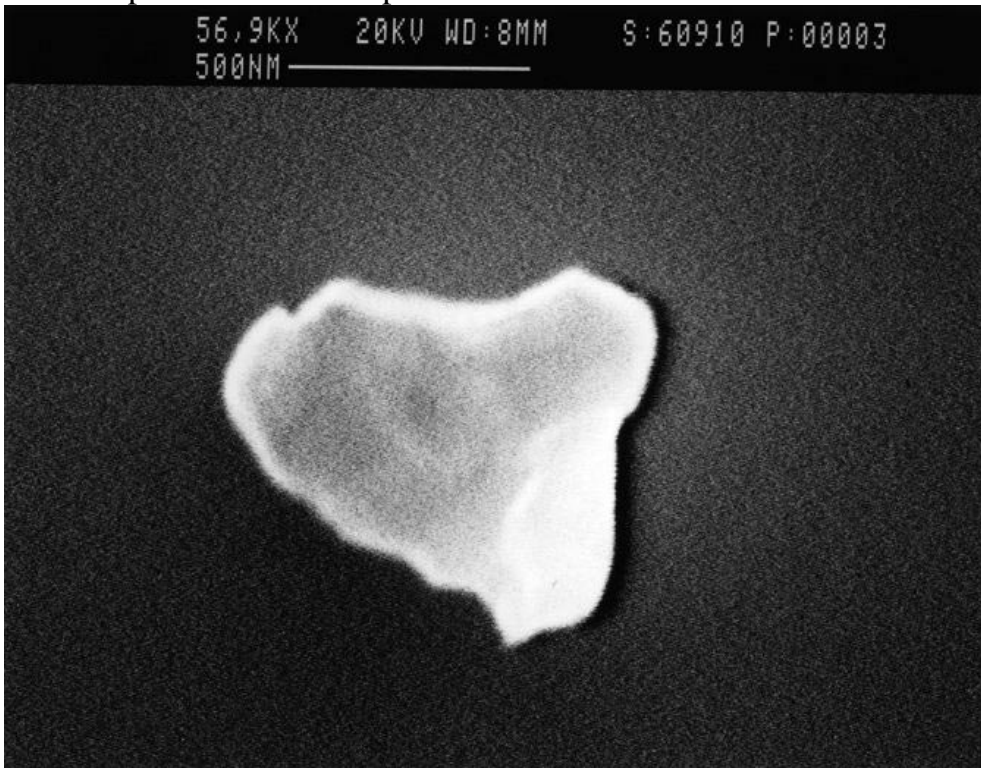
An Iron particle on coupon A1-39
