review of horizontally limiting slits and filters  
2013-03-12

as requested 2012-10-18  
both C and D lines

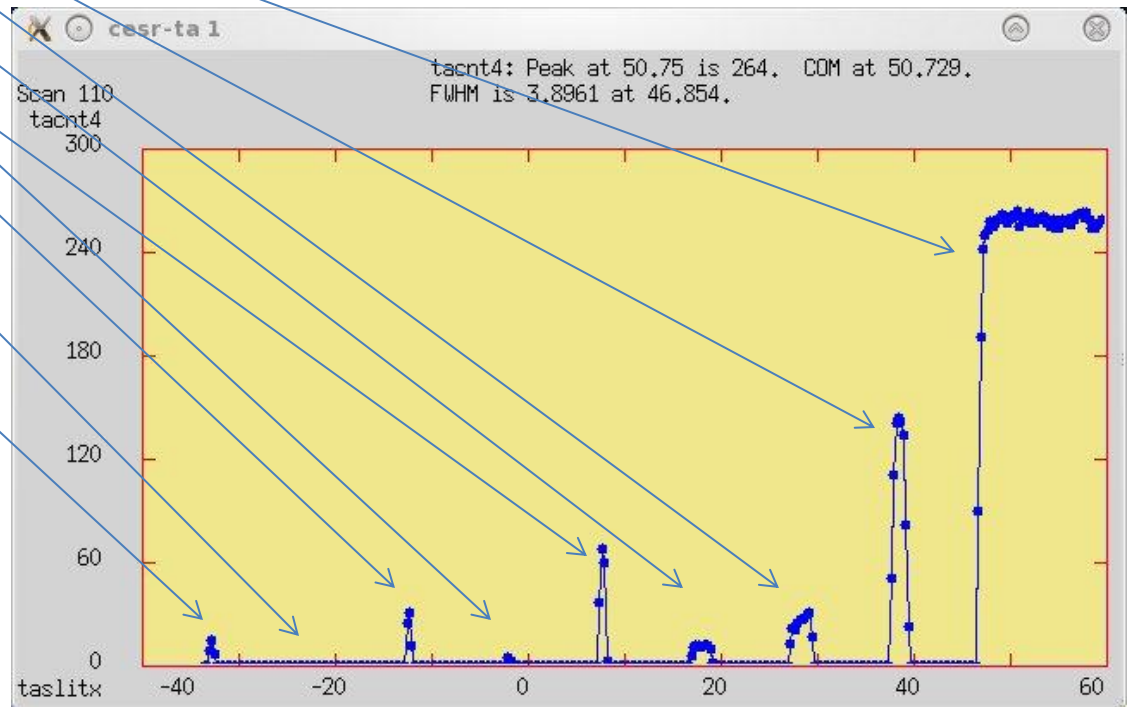
initial slow scan, 2012-11-28, log 1453

seq	aperture	filter	location
			2012-12-06
			log 1485
(0)	>8 mm	none	50
(1)	>2 mm	4 $\mu$ m diam	38.5
(2)	>1 mm	6 $\mu$ m alum	28.9
(3)	>1 mm	2 $\mu$ m moly	18.2
(4)	171 $\mu$ m	none	7.7
(5)	35 $\mu$ m	none	-2.1
(6)	105 $\mu$ m	none	-12.5
(7)	35 $\mu$ m	4 $\mu$ m diam (this one is OK, found with 2.3 GeV)	-22.75
(8)	105 $\mu$ m	4 $\mu$ m diam	-32.9

seq	aperture	filter	location	relative signal 2.3 GeV	width
(0)	>8 mm	none	50	1	{48.5 : 60} log 1453
(1)	>2 mm	4 $\mu$ m diam	38.5	0.5	full width 1mm log 1459, 1466
(2)	>1 mm	6 $\mu$ m alum	28.9	0.15	
(3)	>1 mm	2 $\mu$ m moly	18.2	0.05	
(4)	171 $\mu$ m	none	7.7	0.25	
(5)	35 $\mu$ m	none	-2.1	0.02	
(6)	105 $\mu$ m	none	-12.5	0.15	
(7)	35 $\mu$ m	4 $\mu$ m diam	-22.75	0.01	
(8)	105 $\mu$ m	4 $\mu$ m diam	-32.9	0.05

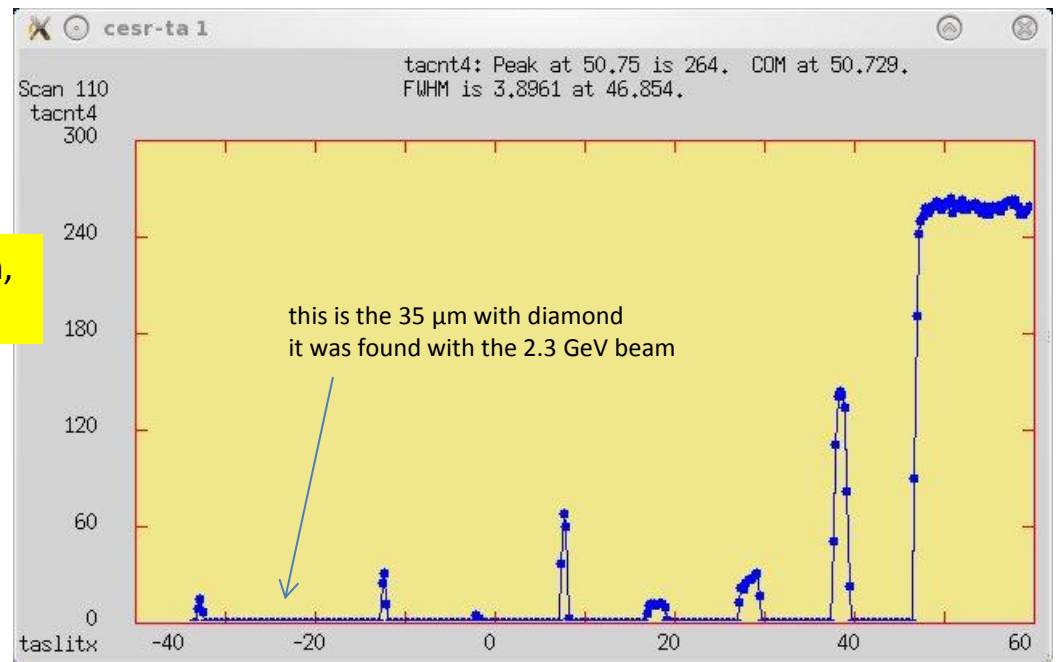
**D-line** initial slow scan,  
2012-11-28, log 1453

compare the C-line with D-line

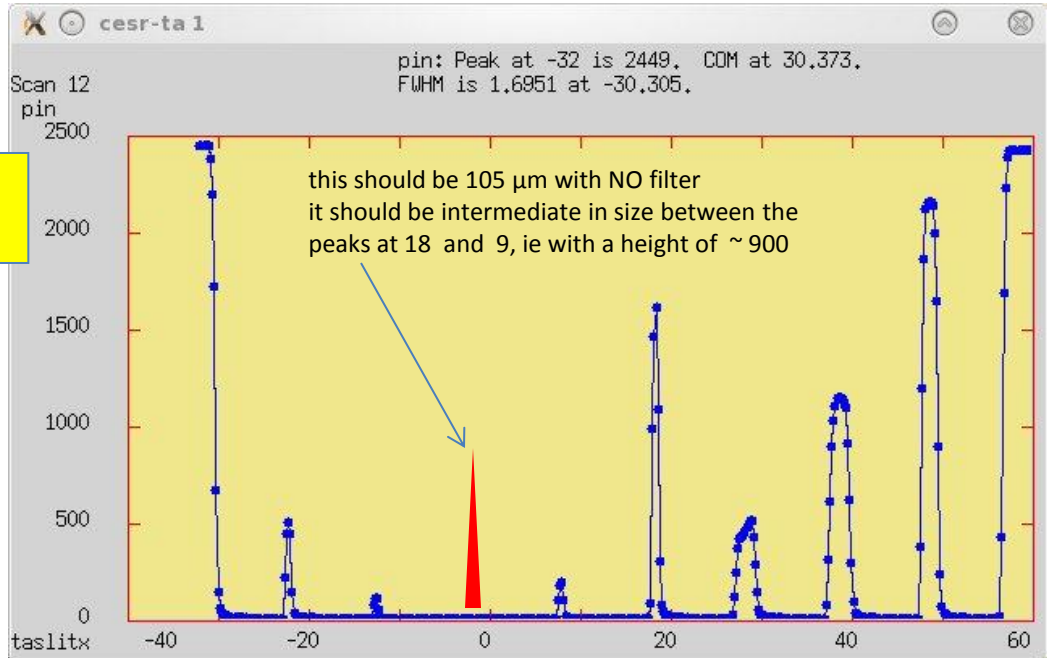
**C-line** initial slow scan,  
2012-11-21, log 1438

We do not know why there is no light through the slit #6.

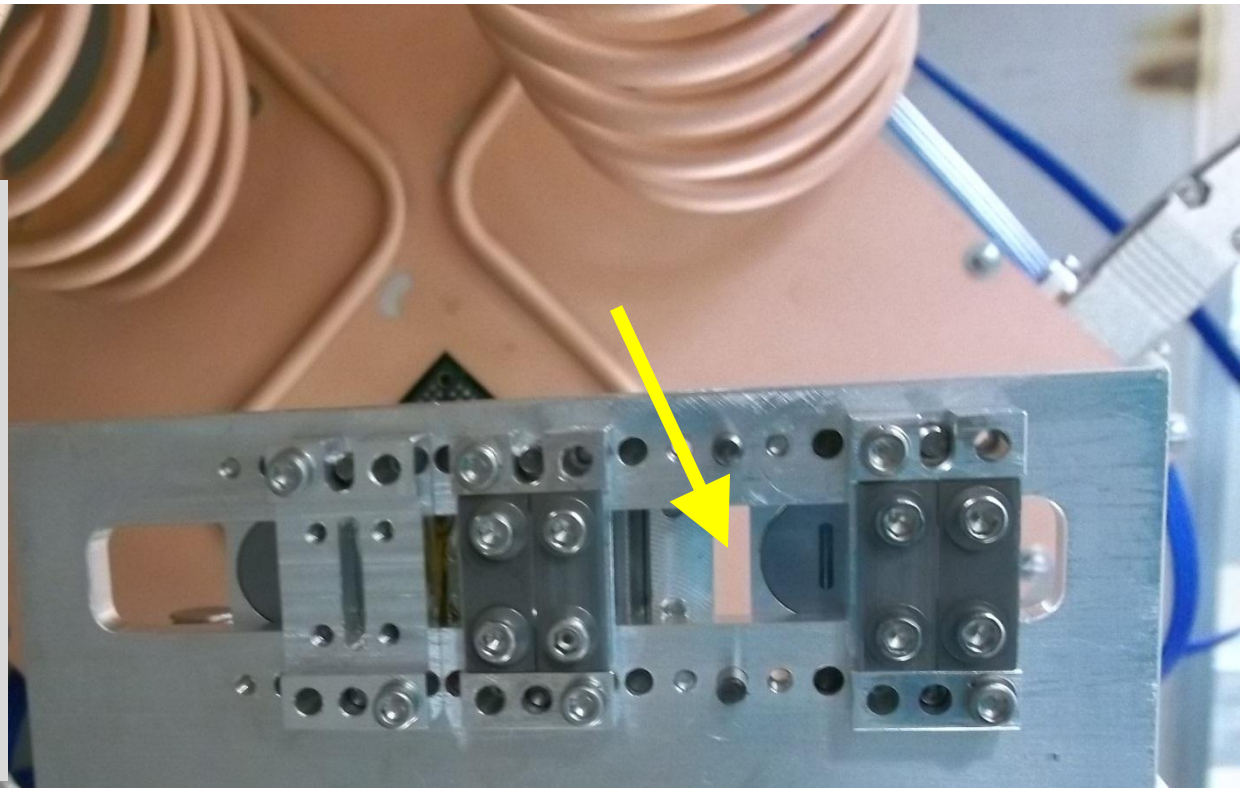
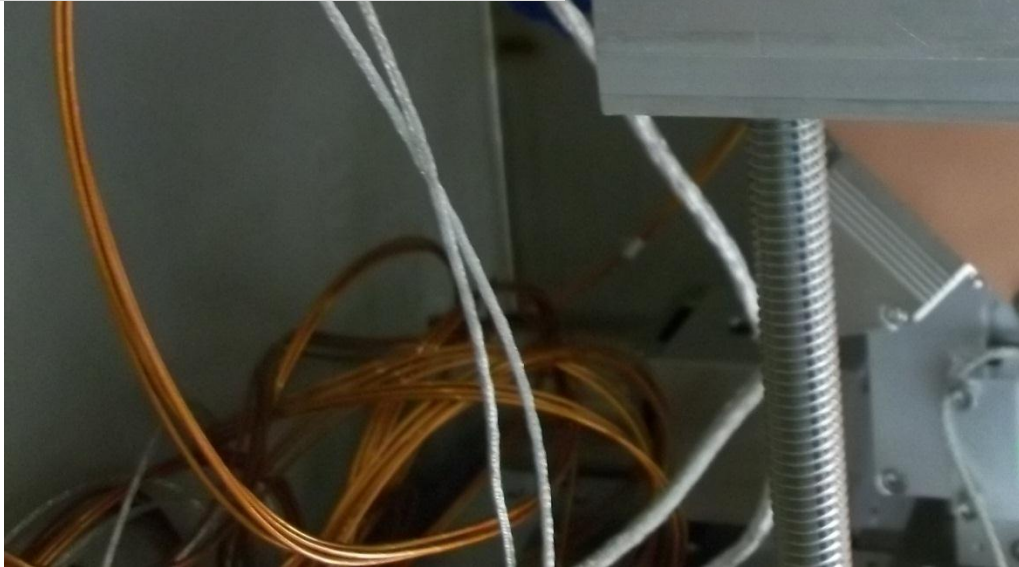
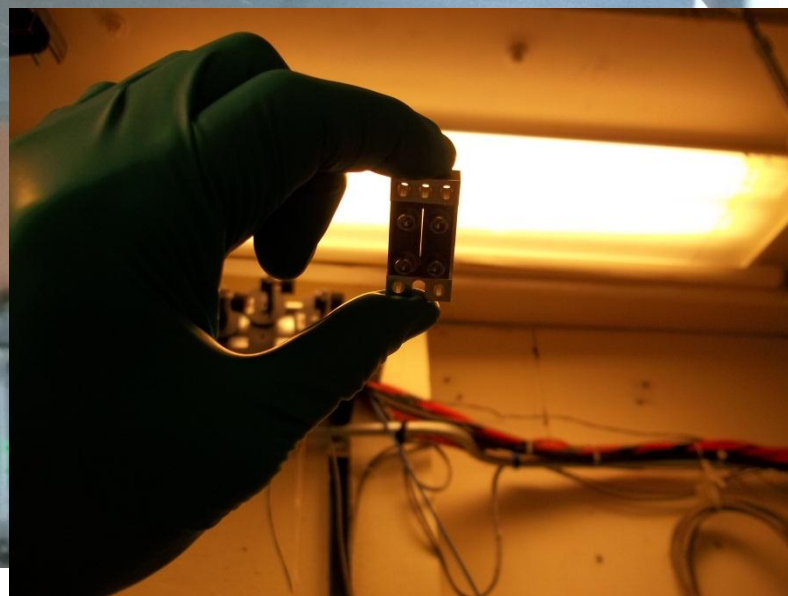
On 2012-11-27, we asked Aaron to look at the non-transmitting slit in C-line.

Note, the cassette #6 is removed.

For reference, we see the round diamond window in cassettes #1 and #7 as expected.

The inset shows light through the slit.

2013-03-12: verified that this is picture is C-line
