Optimization of RICH Electronics Peformance

Michael Barnes

Department of Physics
University of Arkansas, Fayetteville, AR, 72701

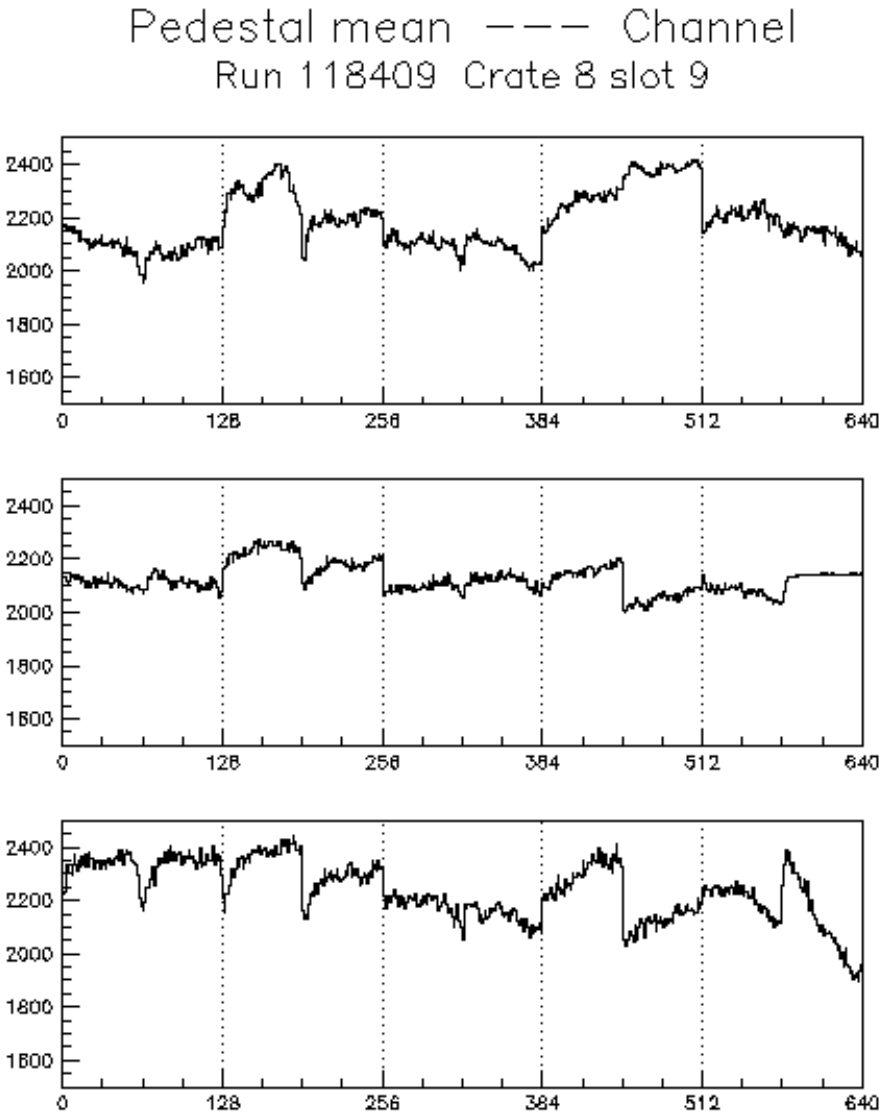
Graphically, flat chips can be identified as those chips whose pedestal plots for small calibration runs resemble flat lines, as opposed to the jagged lines that characterize the pedestal plots of good chips (Fig. 1). These flat lines indicate that each of the chip's 64 channels are reading in approximately the same pedestal value during the calibration run.

FIGURE 1. This is a typical pedestal plot for a board with three chain consisting of 5 chip carriers each, with each chip carrier containing two chips. In chip carrier 5 of the middle chain, the second chip is flat.

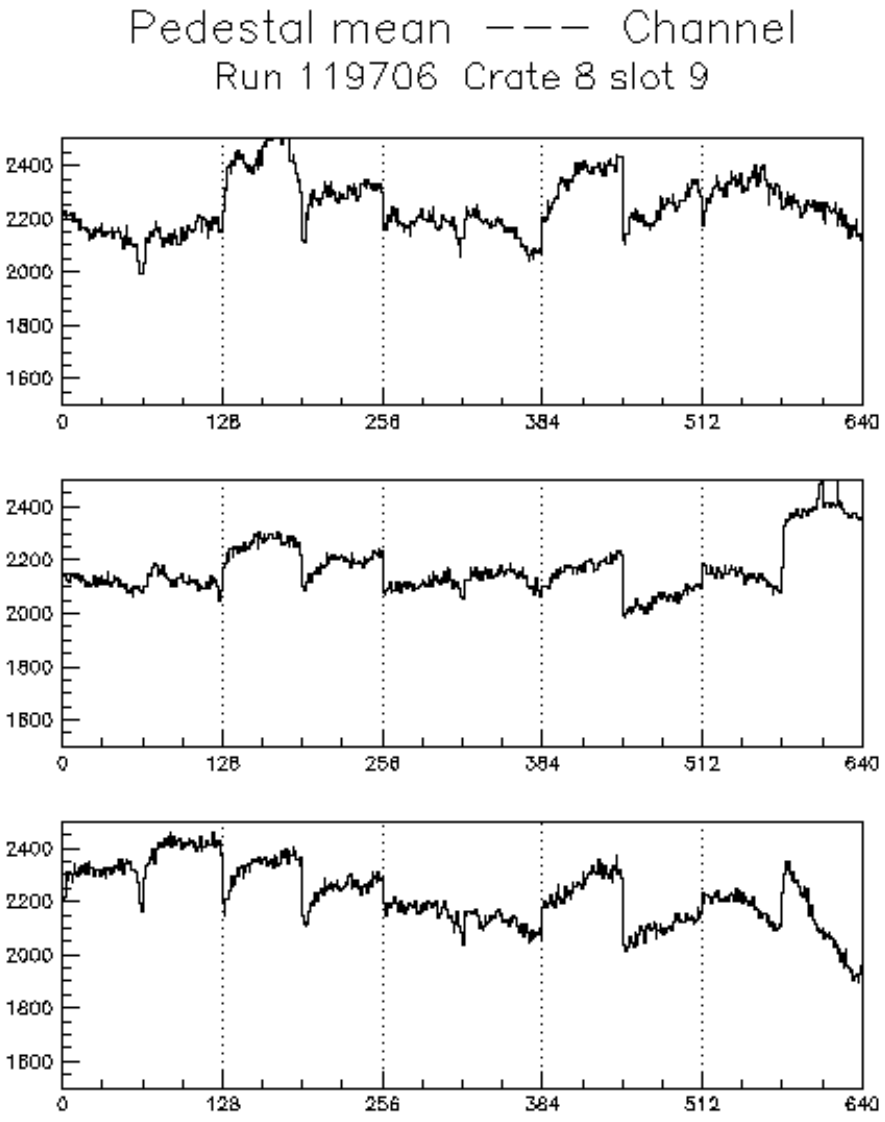
FIGURE 2. This is a pedestal plot for the same 3 chains as Figure 1, but taken during a later calibration run. As you can see, the flat chip from Figure 1 now appears to be functioning properly.

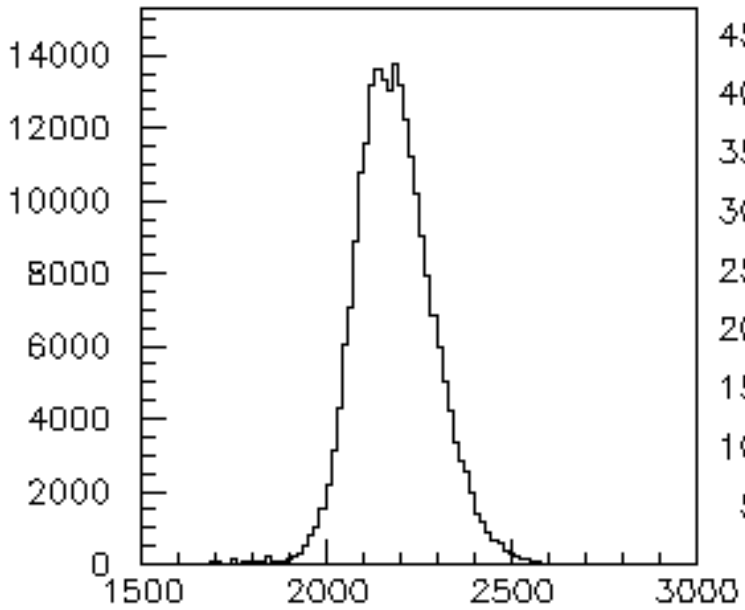
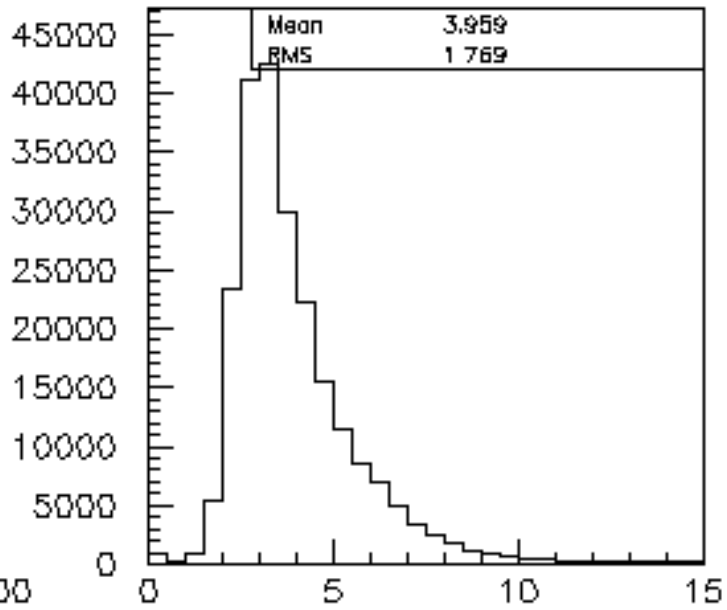
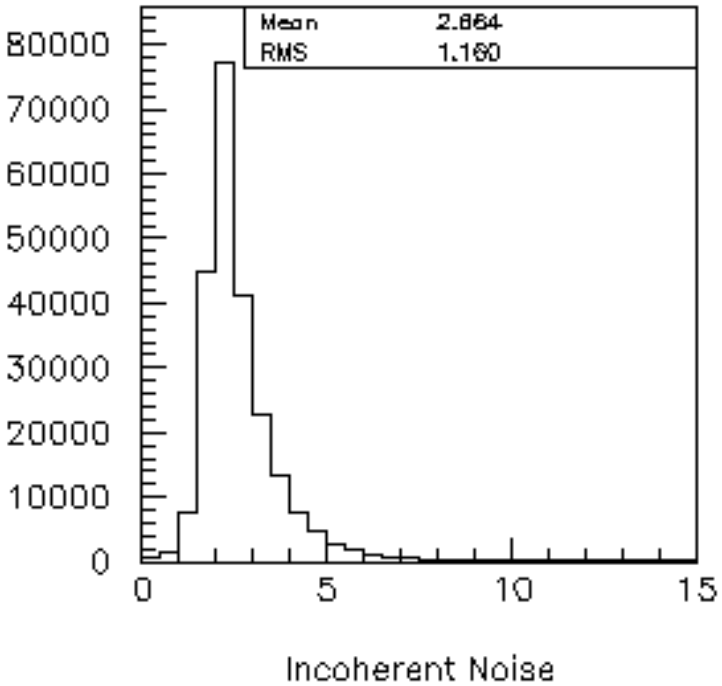
FIGURE 3. These are typical histogram plots for pedestal values, total noise, and incoherent noise in the RICH detector

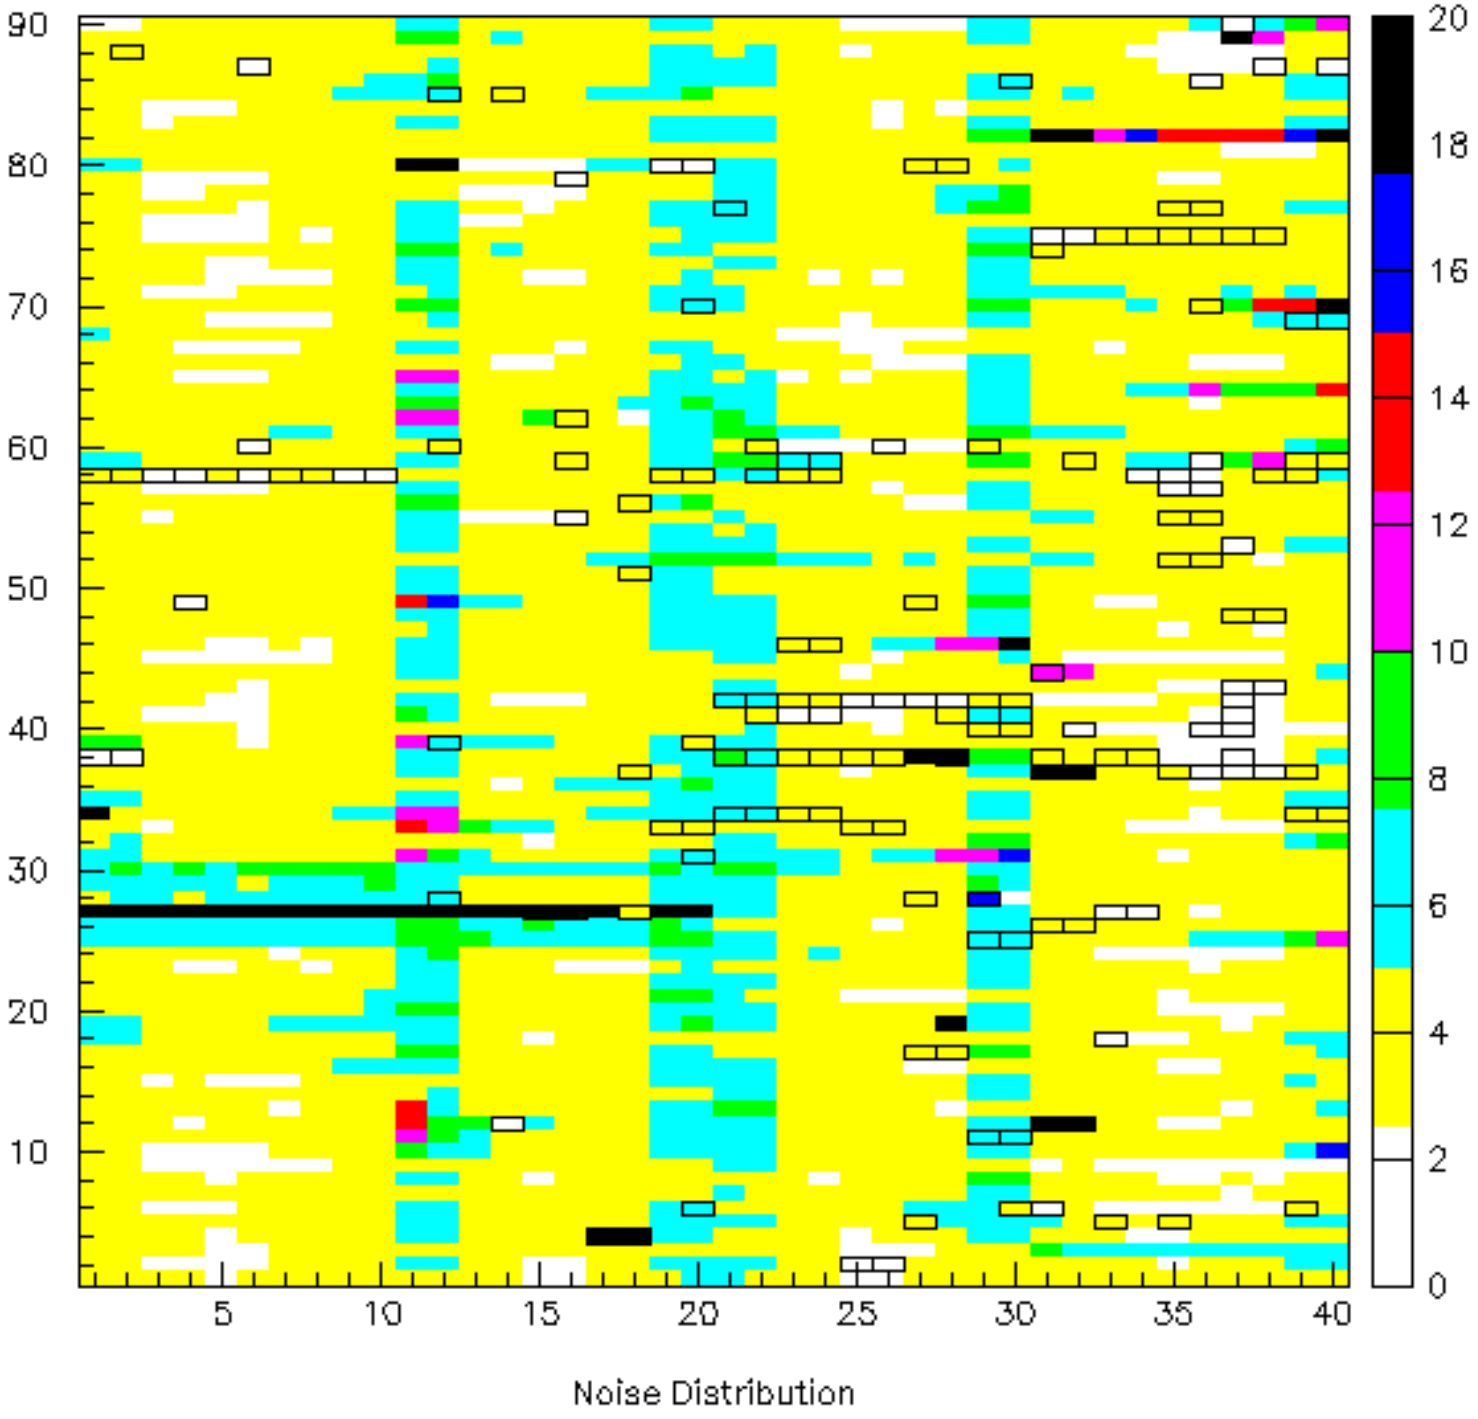
FIGURE 4. Geometrical distribution of total noise and flat chips. Noise levels are represented by a color map, and flat boxes are represented by black boxes

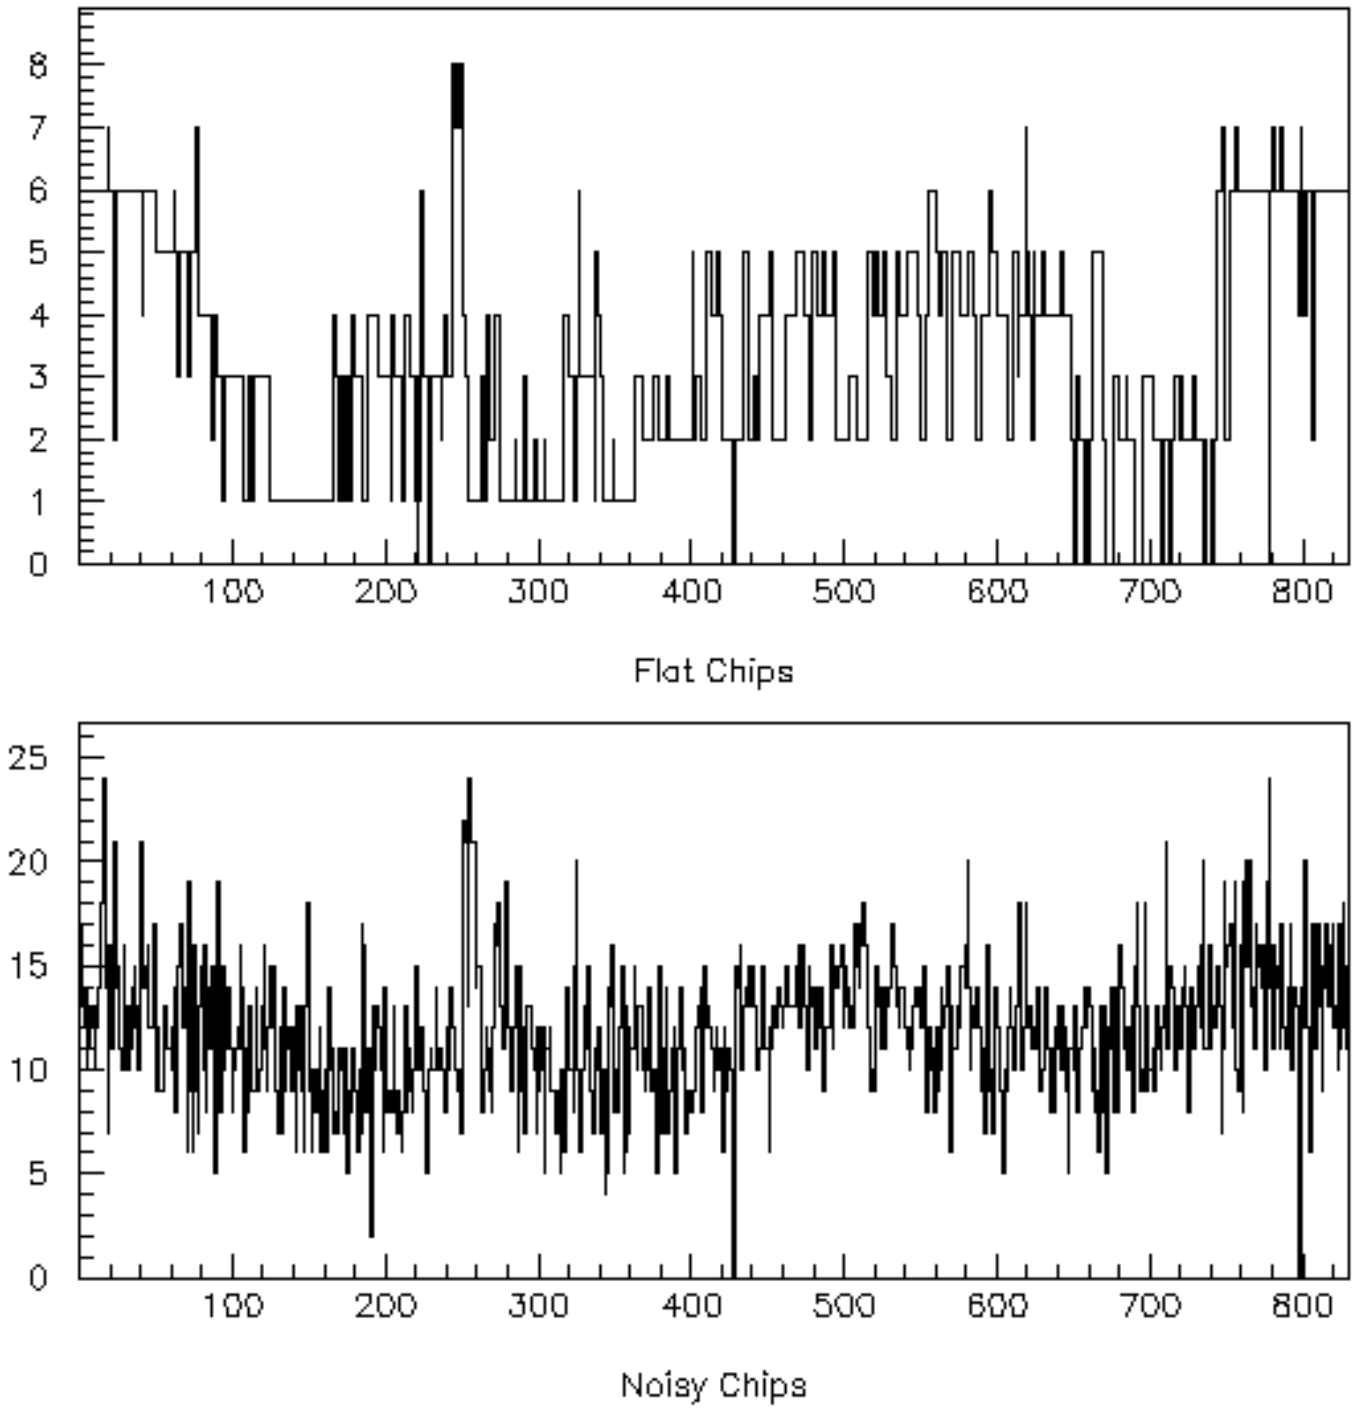
FIGURE 5. The top plot depicts the number of flat chips in chamber 12 over the course of around 850 runs. The bottom plot depicts the number of chips with noise values greater than 6 over the course of the same runs.

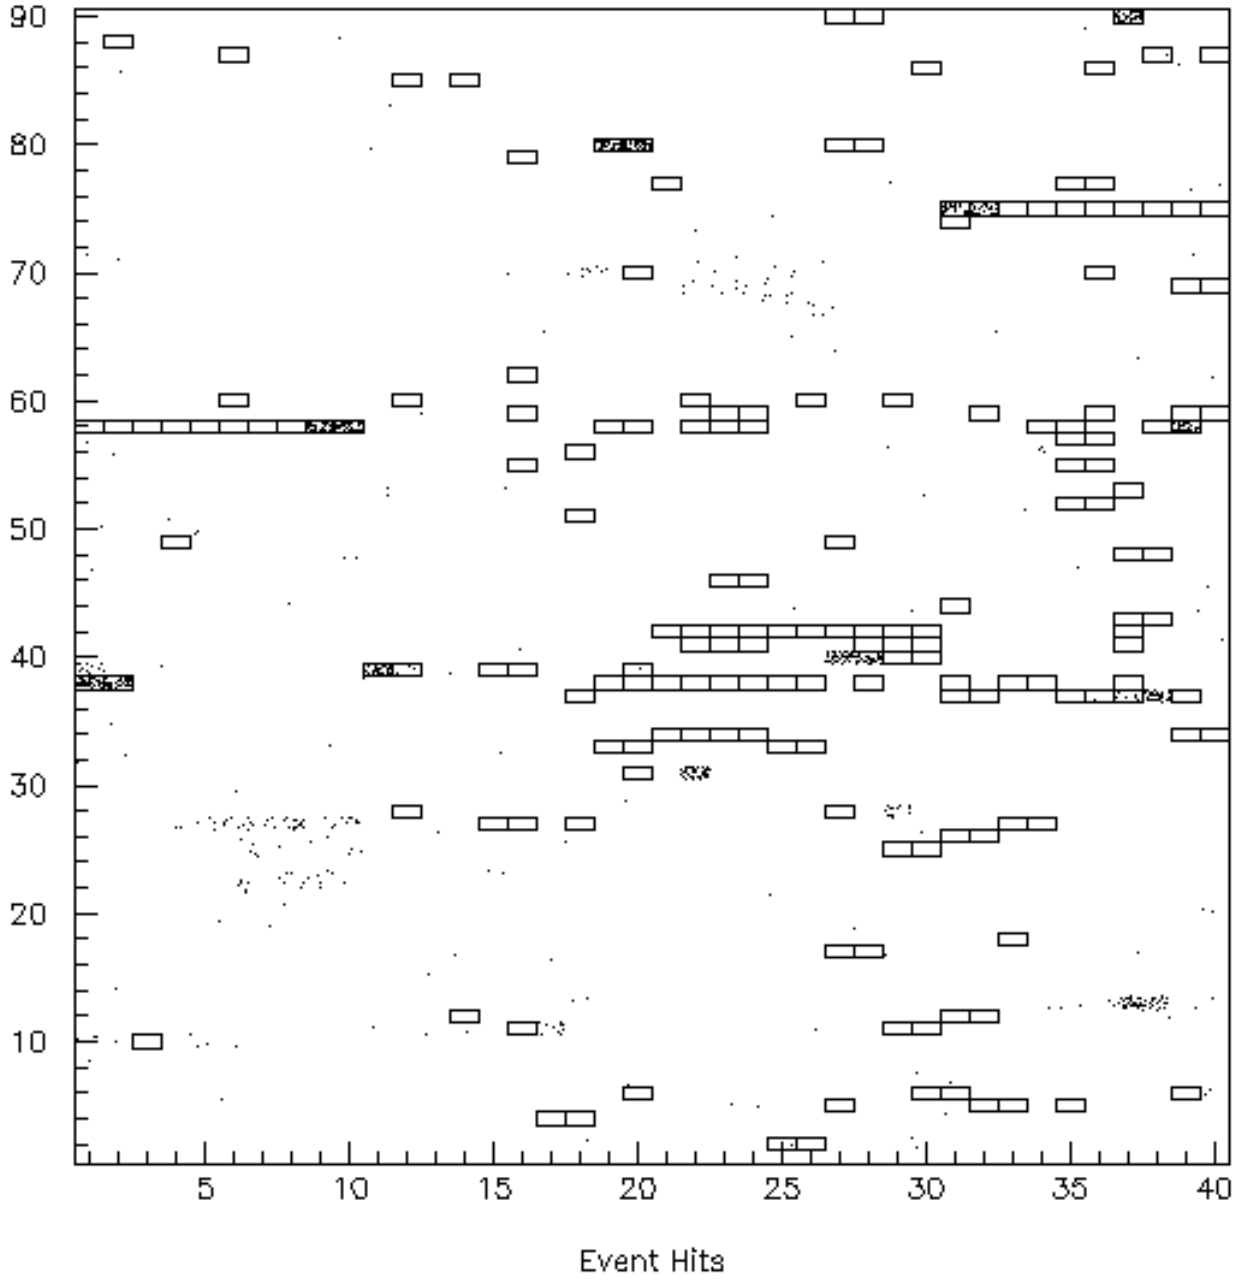
In addition to studying the time frame for the creation of white boxes, I investigated the possible relationship between white boxes and flat chips. An already existing C++ program was modified in order to generate a plot of the geometrical distribution of both white boxes and flat chips for individual events (Fig. 6). From this plot, it is evident that over half of the white boxes correspond to chips that were flat during the preceding small calibration run. Since flat chips comprise a small percentage of the total chips in the RICH detector, but comprise a significant percentage of white boxes, it would seem that there might indeed be some sort of correlation between flat chips and white boxes. This indicates that flat chips may be more susceptible to pedestal shifts than normal chips. If this is indeed the case, it lends credence to the hypothesis that latch-up is the cause of flatness, as shifting pedestals can be explained by the high current draws that are experienced during latch-up.

FIGURE 6. Geometrical distribution of 'fake' hits and flat chips in the RICH detector. Black points correspond to 'fake' hits and black boxes correspond to flat chips.
